Manhole Inspection Summary

Manhole # S45EE_049MH

Insp Date: **12/20/07 10:25 AM**

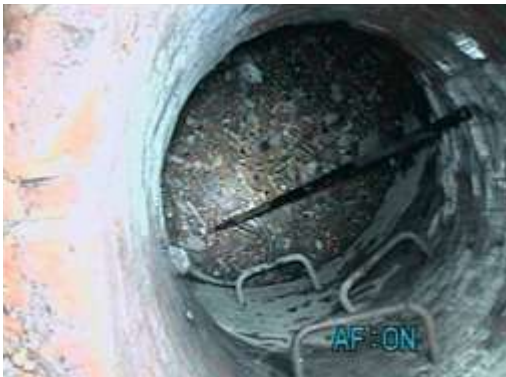
Defect 1

Infiltration: ☐ None ☐ Joint ☐ Cracks ☐ Mortar ☐ Roots ☒ **Wall**

Condition: ☐ Sound ☐ Cracked ☐ Root Intrusion ☐ Deteriorated ☐ Leaks ☒ **Debris**

channel debris, barrel wall infiltration

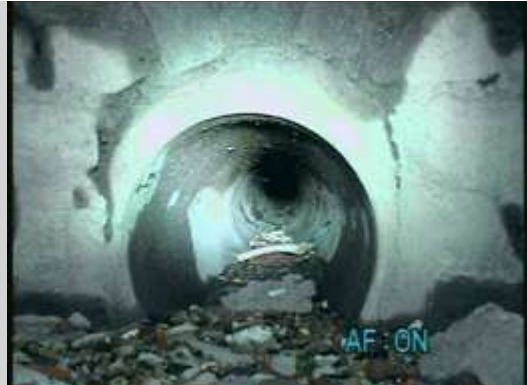
12 O'Clock Outflow

8 in. Circular Gravity Sewer
Pipe Out @ 12 O'Clock

Deposits: ☐ None ☐ Mud ☐ Sludge ☒ **Debris** ☐ Grease

Silt Depth: **1.5** (in.) Deposits Extent: **Light**
